Technical Bulletin

No: TDL-0114-B
Page 1 of 2
ITDL-0039-B

Issue Poor spinning due to tub support not flat.

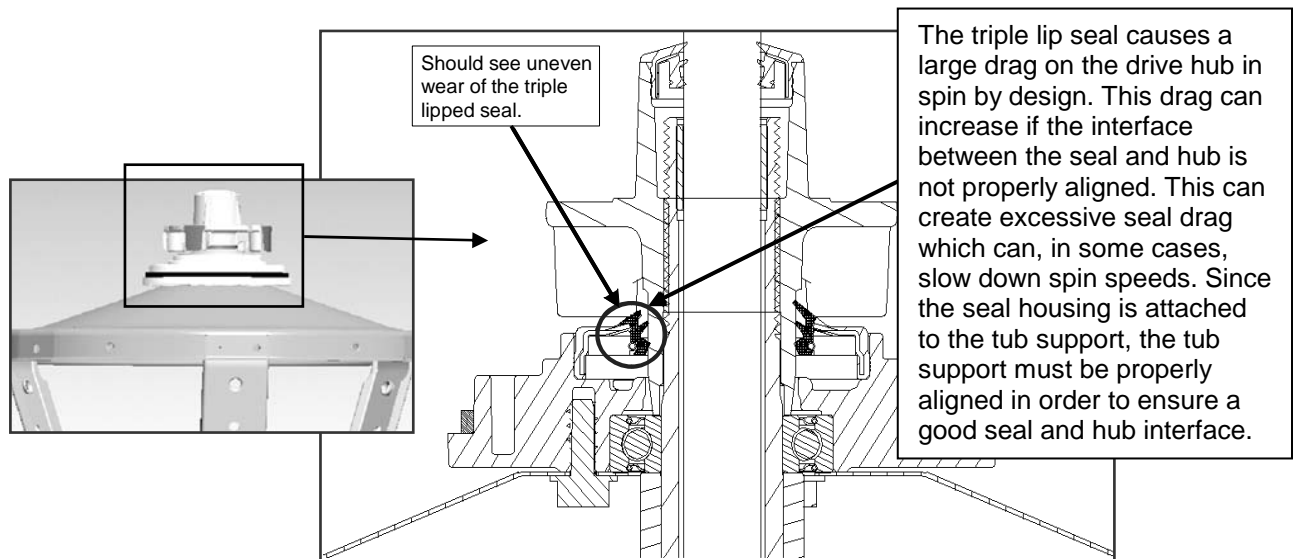
If you can see uneven wear of the triple lip seal, check to see if the tub support is bent.

NOTE: In some cases, rotating the Tub Support about the leg braces can improve the condition but is not at all a guarantee.

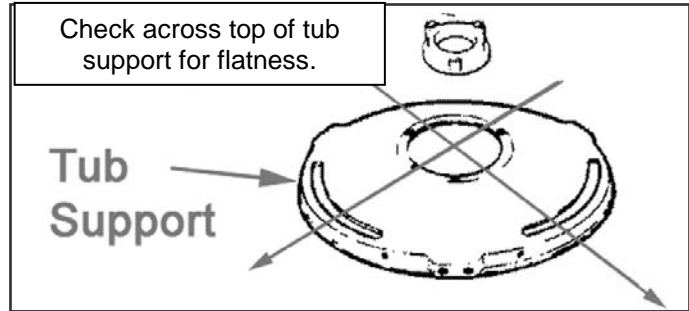
Verify if the tub support is bent by taking the support off, placing it on a level surface and checking for level across the top of the support.

If the tub support is bent, then replace the tub support part no. 21001518.
