Technical Bulletin

No: TDR-0003-B
Page 1 of 1

Brand
Amana

Models All 18 and 21 cubic foot Bottom Mount Drawer models which include BRD18 and ARB2117.

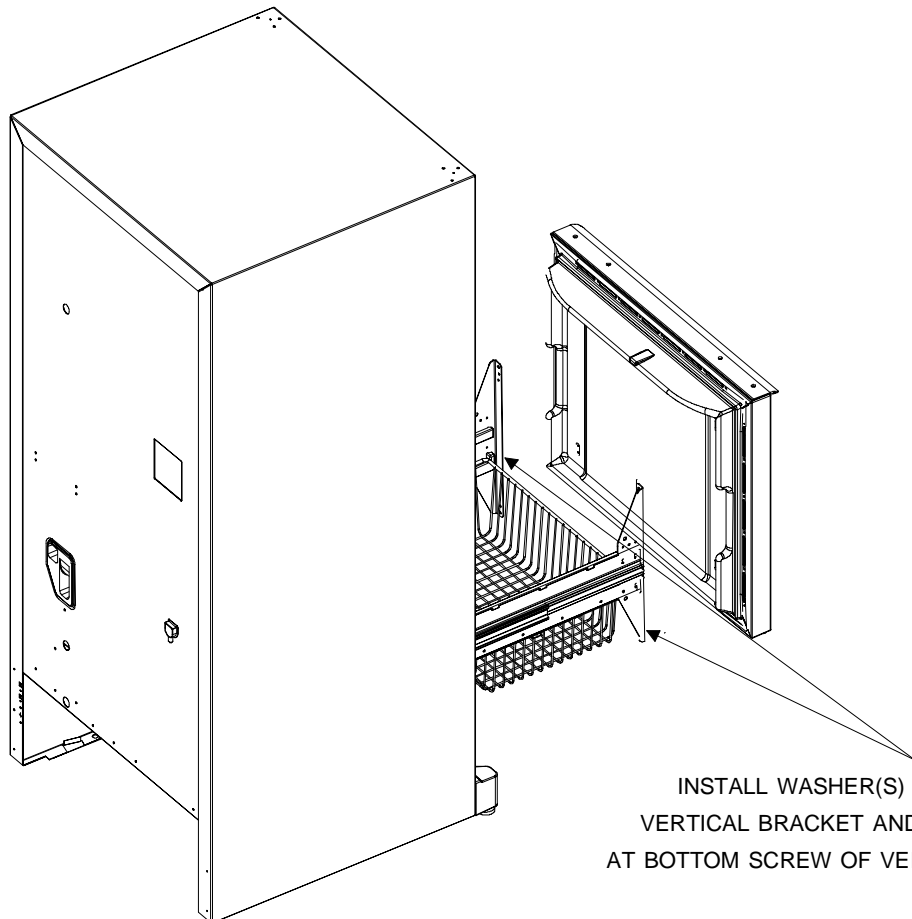
Issue Lower edge of Freezer Drawer pitched inward resulting in top of drawer not sealing.

Action On the bottom of each vertical door-mounting bracket remove the bottom screw that attaches the bracket to the inner door liner and loosen the screw just above (See Illustration below).

Between the bottom vertical bracket mounting screw hole and door liner add steel washer(s) as required to pitch the bottom of the door back and away from cabinet, now allowing the drawer gasket across the top of the door to seal to the center mullion. The exact number of washer(s) needed will vary.

It is only necessary to add the washer(s) at the bottom screw hole location in the vertical bracket. Use washer(s) part number M0270509 (.750 OD x .280 ID x .035 THK) or equivalent to serve as the spacer.
