Technical Bulletin

Models All Maytag built Side by Side Dispenser & Non Dispenser Models
1998 to Current.

Issue Hollow Ice and Clumping and Jamming of Ice.

Description: Icemaker Air Tunnel Kit

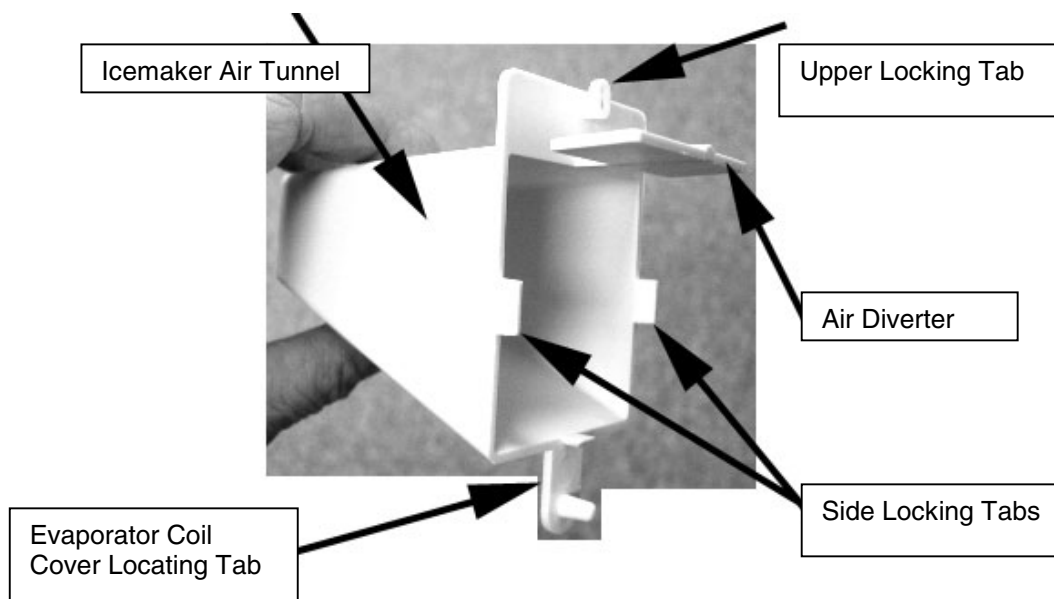
1. Remove the crusher bin assembly and the icemaker.

- Using your finger remove the icemaker air tunnel coil cover-locating tab (this is only used on current production models) See figure 1.

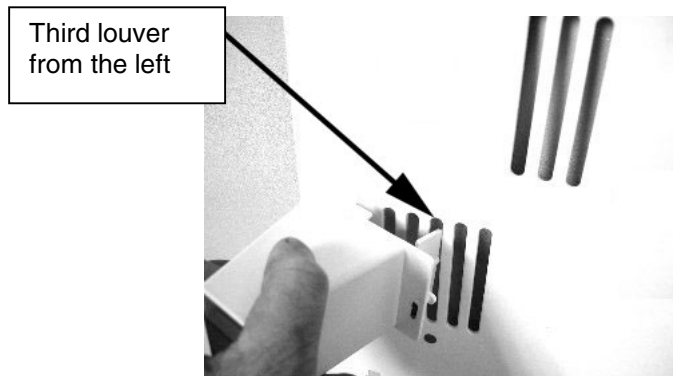
Figure 2

- Turn the icemaker air tunnel 90°. Insert the air diverter into the upper evaporator coil cover louvers, second row third slot in from the left. (See figure 2).

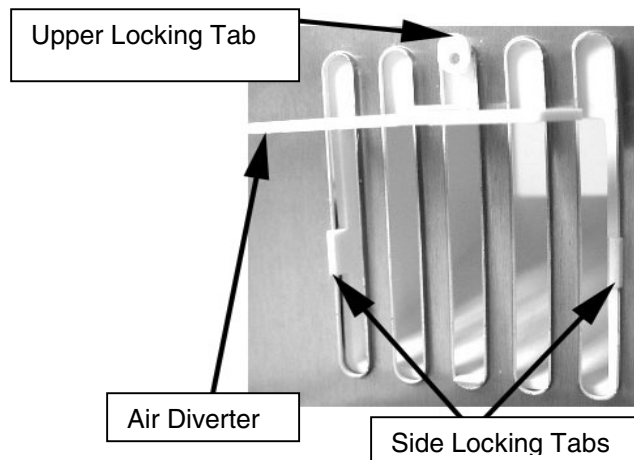
- Rotate the air tunnel counter clockwise 90°. Make sure the side and the upper locking tabs are locked in place behind the coil cover. (See figure 3)

Note: Figure 3 is for reference only - you do not have to remove the evaporator coil cover.
